No: 000295

CHRISTEN INDUSTRIES, INC.  
1048 SANTA ANA VALLEY ROAD  
HOLLISTER, CALIFORNIA 95023  
TELEPHONE: (408) 637-7405

U  
S  
TSubject: CHANGE OF CANOPY AFT  
HINGE ATTACHMENT IN  
EAGLE II AIRCRAFT 904 AND  
915 CONSTRUCTION KITS

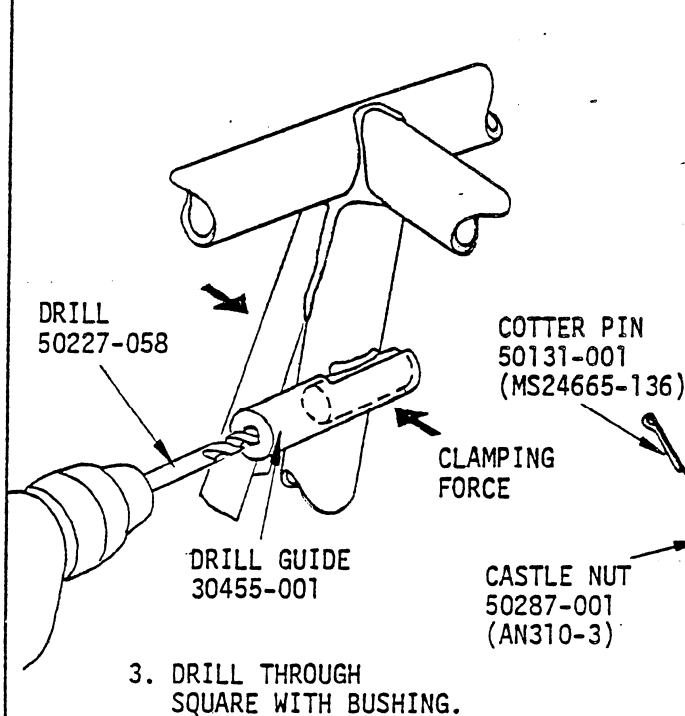
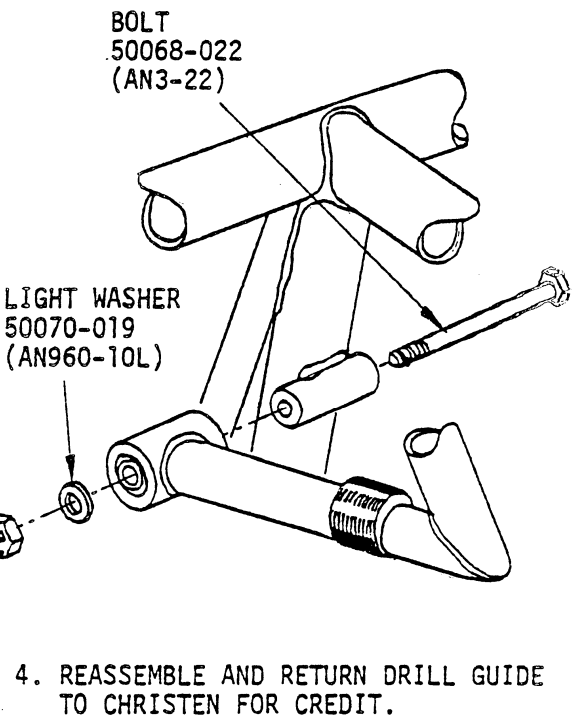
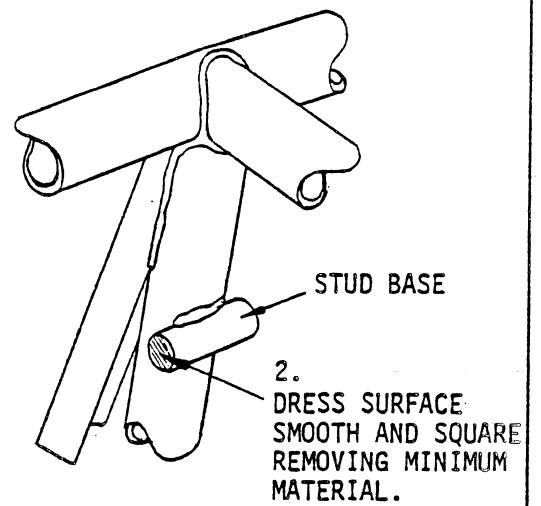
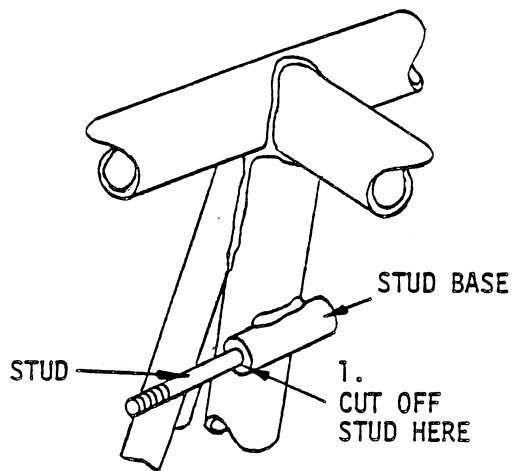
ENGINEERING SKETCH X-90136

Eagle II aircraft fuselage structures manufactured prior to January 1983 used a hinge support stud, located behind the right rear seat armrest, which supported the rear hinge of the canopy system. Several aircraft have experienced failure of this stud.

The fuselage modification procedure for the new hinge attachment consists of trimming off the original stud and drilling through the stud base to form a support bushing through which a new hinge support bolt can be mounted. A special drill guide and drill are required as listed below. (It is essential that a properly sharpened drill be used to ensure hole straightness, location, and angle.)

Modification of the canopy system consists of simply adding a bolt, castle nut and cotter pin to replace the original thin nut and support stud.

8. Secure the castle nut in its adjusted position with the 50131-001 cotter pin. Clinch the prongs of the cotter pin if the aircraft has been completed (through 923 Kit), or spread the prongs only slightly to keep the pin in position, but to allow removal later during remaining construction.
9. Reinstall all rear seat and canopy components as appropriate.
